Inspection Report

Property Address: 3288 Somewhere Dr Whiteriver FI 32738

Valuecast, Inc.

Date: 3/18/2016	Time: 12:50 PM	Report ID:
Property: 3288 Somewhere Dr Whiteriver FI 32738	Customer: It Could Be You	Real Estate Professional:

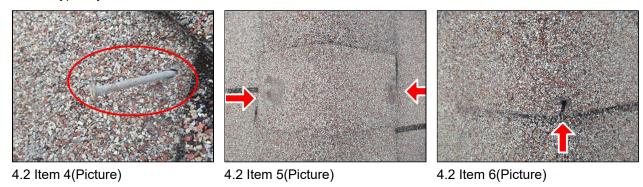
(2) There are areas on the roof where a roofing nail fell bellow the next shingle line is exposed. Sealing is needed to prevent water intrusion and damage as any exposed fastener is a leak source. A qualified roofing contractor should do the job. The sealant typically needs to be monitored and renewed as needed to lessen the likelihood of leaks.
